Tidal Back River Small Watershed Action Plan

Volume II

Tidal Back River Watershed Characterization Report

October 2009

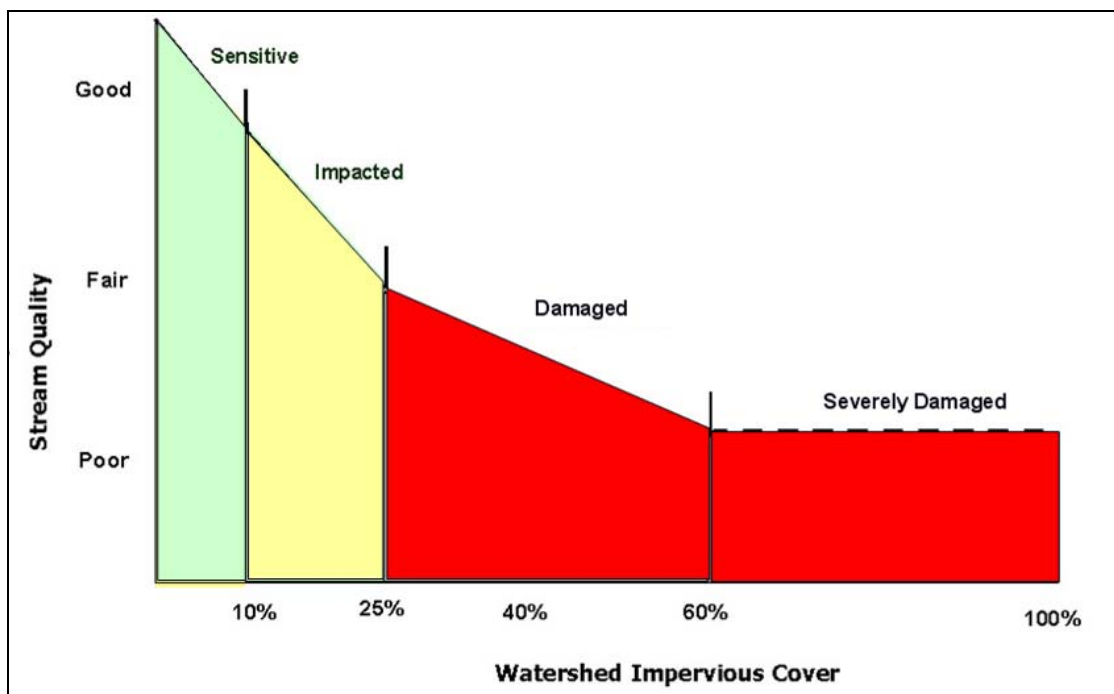
Figure 2-11: Impervious Cover Model (adapted from CWP 2003)

Impervious cover is a primary factor when determining pollutant characteristics and amounts in stormwater runoff. Research has been conducted to link the degree of urbanization (typically measured by amount of impervious cover) with various watershed-based indicators of water quality such as the diversity and abundance of aquatic and terrestrial life. The Center for Watershed Protection (CWP) compiled stream research conducted in various parts of the country and developed a simple model that relates stream quality to percentage of impervious cover in a watershed. Studies used to develop the impervious cover model measured stream quality based on a variety of indicators such as number of aquatic insect species, stream temperature, channel stability, aquatic habitat, wetland plant density, and fish communities. CWP's impervious cover model is illustrated in Figure 2-11.

Based on the research compiled, CWP determined three general categories to classify and predict stream quality in terms of impervious cover. Watersheds with less than 10 percent impervious cover are referred to as sensitive and typically have high quality streams with stable channels, good habitat conditions, and good to high water quality; sensitive watersheds are susceptible to environmental degradation with urbanization and increases in impervious cover.

The model predicts that between 10 and 25 percent impervious cover, watersheds become impacted and would show clear signs of degradation such as erosion, channel widening, and a decline in stream habitat. There is a possibility to restore streams to a somewhat natural functioning system within this category. When a watershed has more than 25 percent impervious cover, streams are classified as damaged which are characterized by fair to poor water quality, unstable channels, severe erosion, and inability to support aquatic life and provide habitat; many streams in this category are typically piped or channelized. Figure 2-10 shows that when impervious cover exceeds 60 percent, a watershed is classified as severely damaged and means that most of the natural stream system is gone. Management of damaged and severely damaged streams may focus on decreasing pollutant loads to downstream receiving waters (e.g., installing BMPs) but the ability to restore natural functions, such as habitat, is unlikely. Restoration efforts may also focus on making the remaining stream systems stable, aesthetically pleasing and an amenity to the community. It should be noted that the impervious cover model is a simplified approach for classifying the quality of urban streams. Although it is based on research, there are inherent model assumptions and limitations that should be considered such as regional variations and scale effects. In addition, while impervious cover is a relevant and significant indicator for watershed health, it is only one of many different factors affecting stream health and contributing to the cumulative impacts of development on water quality. For example, agricultural land uses contribute sediment and nutrient loads to receiving waters depending on management practices. Also, the ability of BMPs to offset adverse impacts from urbanized areas is not specifically accounted for in this model.

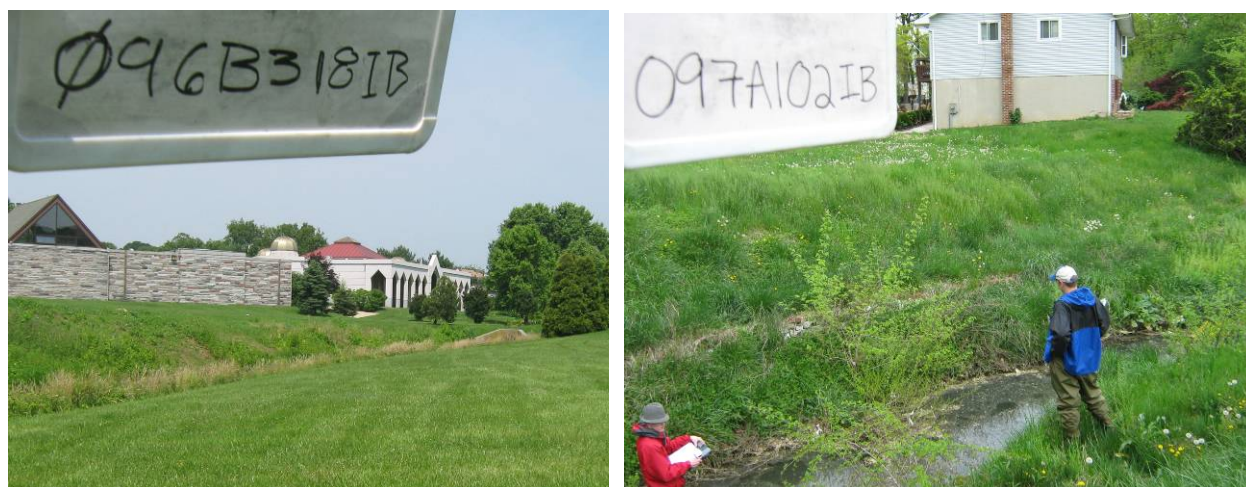
Figure 3-11: Examples of Very Severe Inadequate Buffer Sites (severity rating = 1)

The severity of inadequate stream buffers was rated according to length and width. The most severe sites received a severity rating of 1 if they had a significant length of stream (> 1,000 feet) that was completely open with no trees on either side. Figure 3-11 shows photos of two sites that were considered as very severe inadequate buffers and assigned a severity rating of 1. The photo on the left is a portion of Bread and Cheese Creek in the Oak Lawn Cemetery where both sides of the stream are completely open pervious area. The photo on the right is in Duck Creek where both sides of the stream are residential lawn areas. These two sites represent a potential opportunity for stream buffer reforestation.

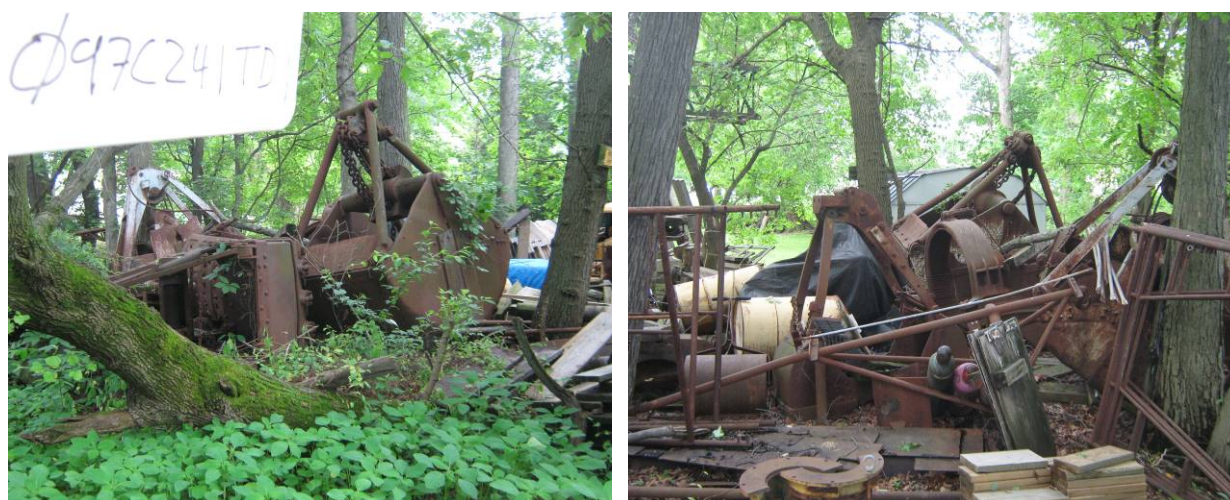
Figure 3-13: Photos of a Very Severe Trash Dumping Site (severity rating = 1)

Trash dumping sites were a prevalent environmental problem in the streams surveyed. A total of 43 trash dumping sites were documented as part of the Tidal Back River SCA survey. The severity of trash dumping sites was rated according to the amount and type of trash present, its location, and whether cleaning up the trash would present problems (access and safety). The amount of trash was estimated in terms of number of pick-up truck loads. Type of trash was classified as one of the following: residential, industrial, yard waste, floatables, tires, construction, or other. A very severe rating (severity rating = 1) was assigned to sites where large amounts of trash were scattered over a large area, where access is very difficult. Sites with indications of any hazardous materials such as chemical drums were assigned a very severe rating regardless of the amount. Moderately severe trash dumping sites (rating = 3) are those with a fairly large amount of trash in a small area with easy access that could be cleaned up in a few days. Most of these sites represent volunteer opportunities; however, volunteer cleanup potential can be limited by various factors such as site access, safety, or the need for small backhoes. Low severity and minor trash dumping sites (rating = 4 or 5) are those with easy access and typically where there is potential for a volunteer cleanup. Figure 3-13 shows an example of a trash dumping site in Muddy Gut considered as very severe (rating = 1) since potentially hazardous materials were stored adjacent to the stream corridor including construction equipment, machinery, and drums. Figure 3-14 shows examples of moderately severe (rating = 3, left photo) and low severity trash dumping sites (rating = 4, right photo). The left photo is in Bread and Cheese Creek where a relatively large amount (~ 4 truck loads) of residential trash (e.g., bottles) was observed in a large area. The right photo is a site in Deep Creek where approximately two truck loads of residential trash (tires) was observed. Both of these sites were considered as possible volunteer projects.

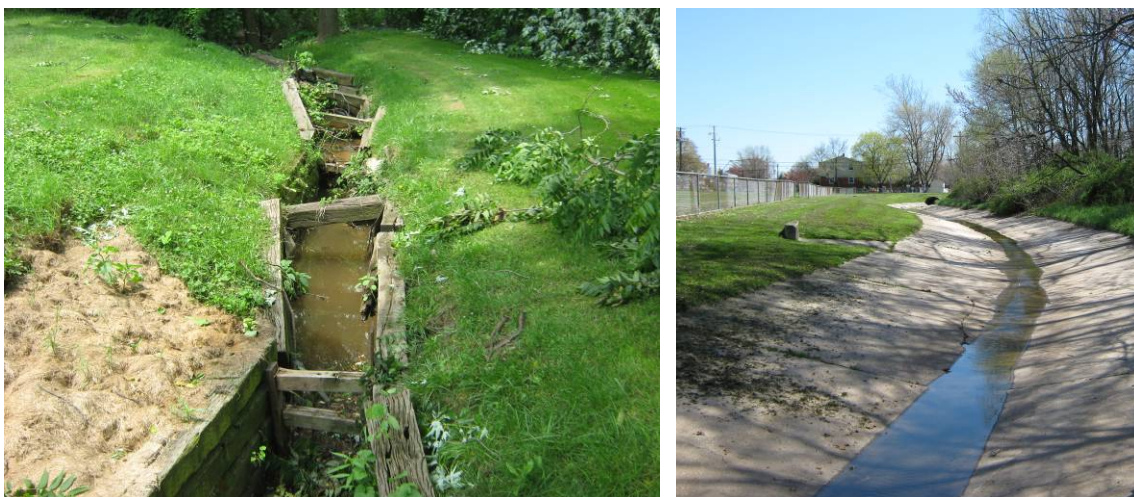
Figure 3-19: Examples of Severe Channel Alteration Sites (rating = 2)

A total of 28 channel alteration sites were documented during the Tidal Back River SCA survey with a total length of 5,254 feet. Less than 10 percent of the total stream miles surveyed (1.0 out of 10.7 miles) were considered to have channel alterations. Severity rating was mainly based on channel alteration length, channel type, and stream functions. The most severe rating of 1 was assigned to concrete channels where water depth was less than ¼ inch with little or no natural sediments present. These channels were generally open to full sunlight over long stretches (> 1,000 feet). Channel alterations were considered moderately severe (rating = 3) if a significant length had been channelized (> 500 ft) but show signs of stabilization and natural stream functions such as sediment bars and vegetation. Minor ratings (rating = 5) were assigned to earthen channels less than 100 feet in length with good water depth, a natural sediment bottom, and with a size and shape similar to unchannelized reaches upstream and downstream of the site. Figure 3-19 shows examples of severe channel alteration sites (severity rating = 2) encountered in the Tidal Back River watershed. The photo on the left is a site along Bread and Cheese Creek where timber retaining walls had been installed and were slightly undermined and rotting with some erosion around the walls. The photo on the right is a site along Deep Creek where a long portion of the stream channel (300 feet) is concrete with no shading and very little water depth.

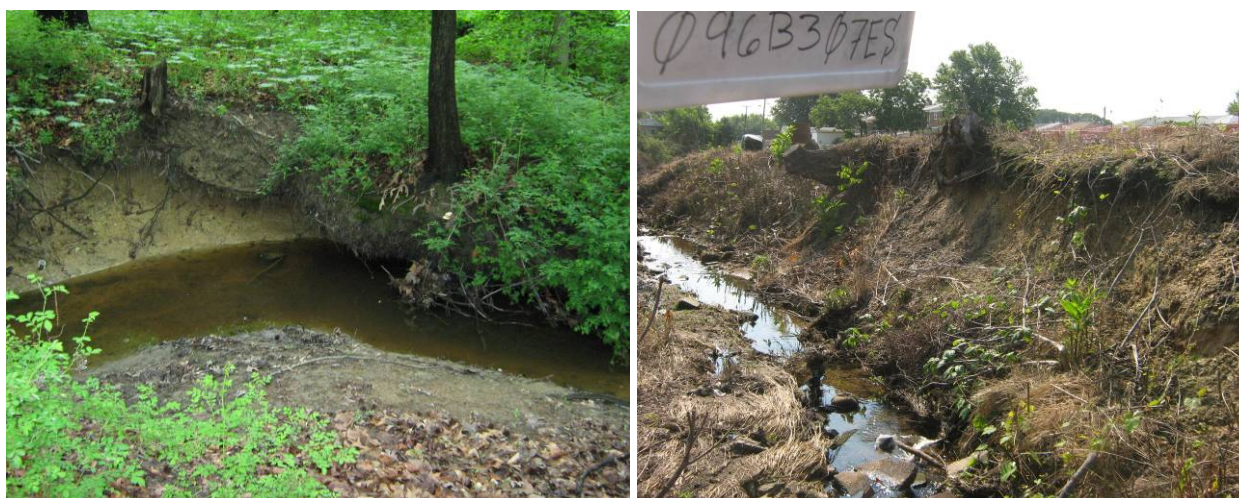
Figure 3-20: Examples of Moderately Severe and Low Severity Erosion Sites

A total of 26 erosion sites were documented during the Tidal Back River SCA survey with a total length of 2,046 feet. Less than 5 percent of the total stream miles surveyed was considered to have erosion problems (0.4 out of 10.7 miles). The severity of erosion was rated based on length and height of the eroding stream bank. The most severe rating (rating = 1) was assigned to sites with long sections of incision (> 1,000 feet), with unstable banks on both sides, and that were eroding at a fast rate. Erosion was considered minor (rating = 5) if it was a short stream section (< 300 feet) where the affected area was fairly limited. Figure 3-20 shows examples of moderately severe (rating = 3) and low severity (rating = 4) erosion sites identified during the SCA survey. The photo on the left is an erosion site along Muddy Gut which was approximately 400 feet long with banks approximately 2.5 feet high. The photo on the right is erosion occurring along a 50-foot stretch in Bread and Cheese and appears to be a result of land use change upstream (construction activity).

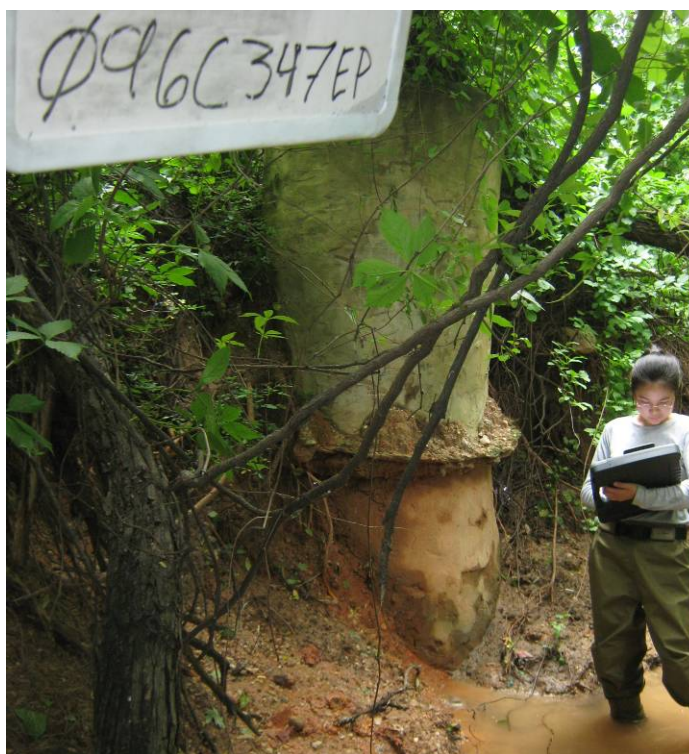
Figure 3-21: Examples of a Potentially Severe Exposed Pipe Problem (rating = 2)

Similar to pipe outfalls, none of the exposed pipes identified were rated as a very severe environmental problem. Of the 7 documented during the SCA survey, 1 was considered as a potentially severe problem (severity rating = 2) and 2 were considered moderately severe. The remaining 4 exposed pipes were considered low severity or minor issues. Figure 3-21 shows a photo of the exposed pipe considered as a potentially severe problem. This was an exposed manhole in Bread and Cheese Creek and was rated as severe because of the large exposed section, its proximity to the stream, and since it carries sewage.

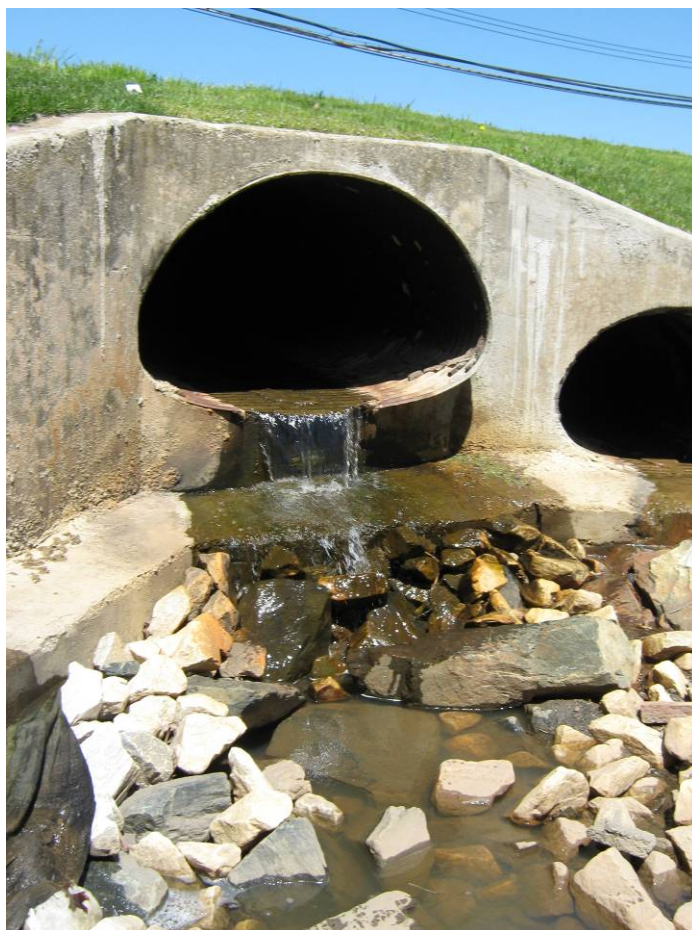
Figure 3-23: Very Severe Exposed Fish Migration Barrier (rating = 1)

Fish barriers observed were nearly evenly distributed among the four subwatersheds surveyed. Most of the fish barriers were rated as moderately severe or low severity blockages with one considered as very severe (see Figure 3-23). This blockage was the result of a road/pipe crossing in Deep Creek that was very high and completely blocked fish migration. Most of the fish barrier sites identified (11 out of 14) were a result of road crossings where the blockage was either too high or the depth was too shallow for fish passage. Two of the low severity sites were a result of debris dams and one of the severe-rated sites was a result of failed rip-rap.

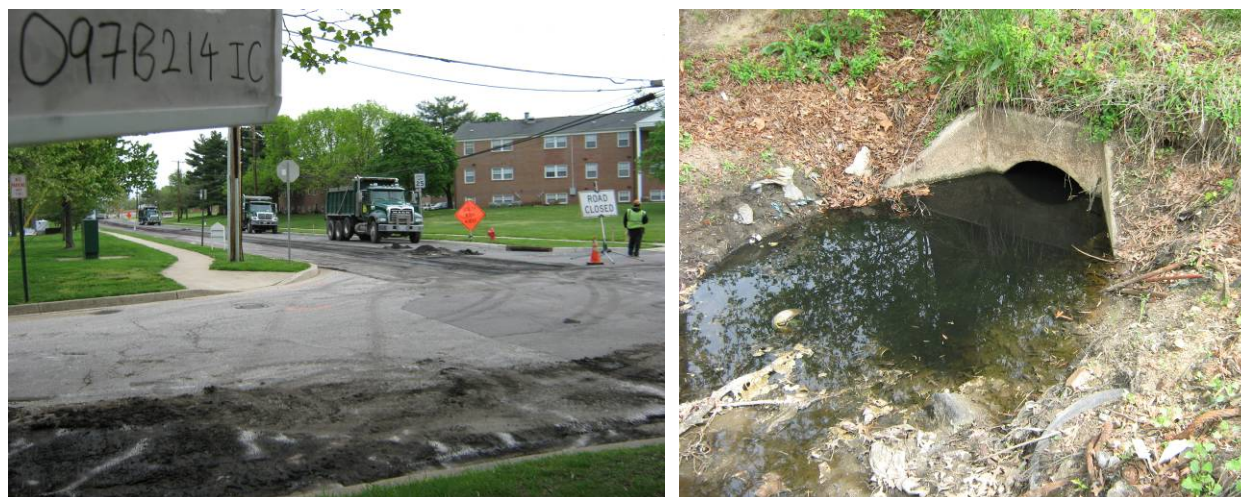
Figure 3-24: Severe Near Stream Construction at the End of Mansfield Road

A total of 1,480 feet (0.3 miles) of construction activity was observed during the SCA survey in Tidal Back River. As shown in the table above, construction activity was observed in portions of all streams except Duck Creek. Two sites were rated as a potentially severe environmental problem. One site was located at the end of Edsworth Road along Bread and Cheese Creek and was the development of a recreation area (this site was also shown in the photo on the right of Figure 3-20 as an erosion concern). This site appeared to have adequate sediment controls and no excess sediment entering the stream as a result of the activity; however, the stream buffer appeared to have been completely cleared as a result of this construction. The second site was at the end of Mansfield Road where road resurfacing activities were taking place (see Figure 3-25). Excess sediment input into Deep Creek was observed as a result of this activity and inadequate sediment control measures were noted by the field time (no inlet protection).

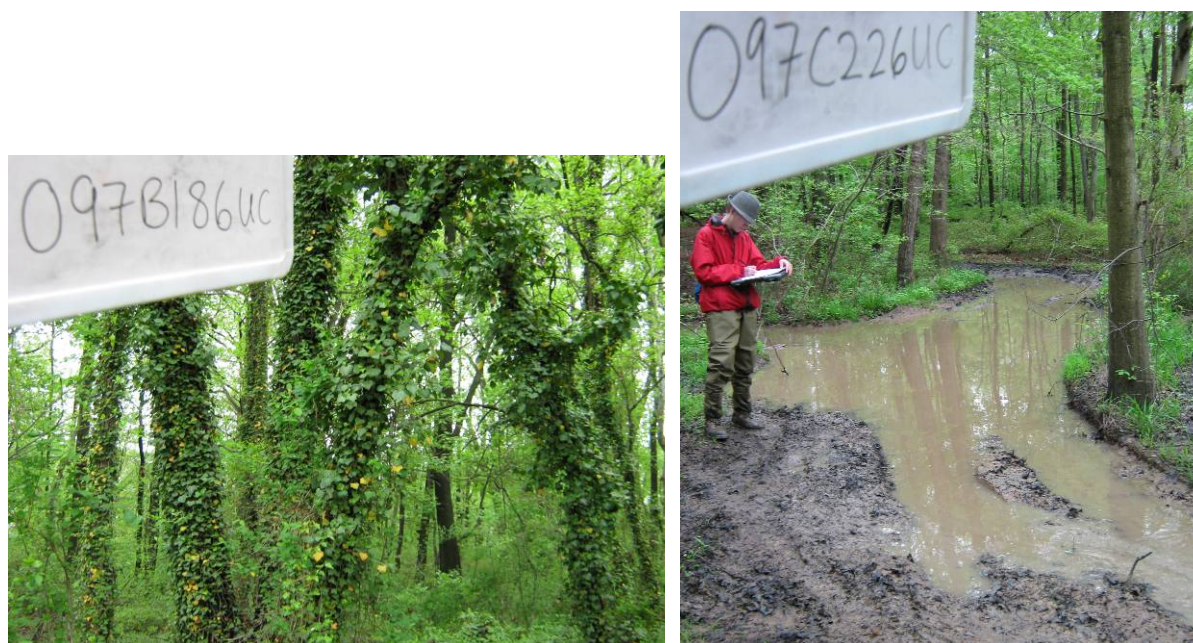
Figure 3-25: Potentially Severe Unusual Conditions (rating = 2)

A total of 40 unusual condition forms were completed; 8 of these were used to provide additional comments for specific problems. For all 40 sites, the most common unusual conditions encountered were presence of ferric oxide (10 sites), stream bank destruction as a result of all terrain vehicle (ATV)/mountain bike trails (7 sites), invasive species such as English Ivy and Japanese Knot Weed (6 sites), and excessive algae (3 sites). Most unusual conditions encountered were rated as moderately severe environmental problems. The two very severe conditions were used as additional comments. One site was located in Duck creek and used to document a large area of English Ivy killing trees and invading a wetland (see Figure 3-25, left photo). The second site was used to document disturbance to the streambed, banks, and forested wetlands as a result of ATV use in Muddy Gut (see Figure 3-25, right photo). Unusual conditions documenting stream impacts related to ATV use and excessive algae may be addressed via public outreach/education type projects. For example, fertilizer reduction/education may help address algae growth resulting from nutrient or chemical use by adjacent properties.

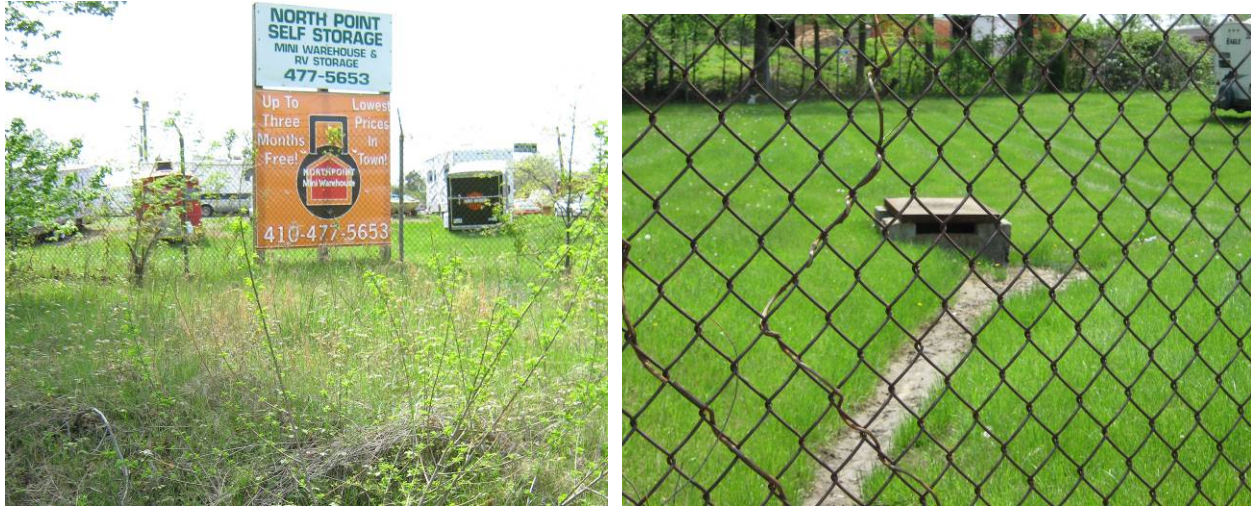
Figure 3-27: Detention Pond SWM-04 (North Point Rd, Back River-A)

property was a secured gate. The existing vegetation is low consisting mainly of patchy grass. The outfall was in poor condition with debris, trash, and sediment noted. Downstream channel continues through a culvert under 695 S which was determined to be in good condition. The adjacent land use conditions make lateral expansion of this detention unlikely. However, since the pond is mainly open pervious/grassed area, there is potential for deepening the pond and incorporating vegetation to improve water quality treatment potential.

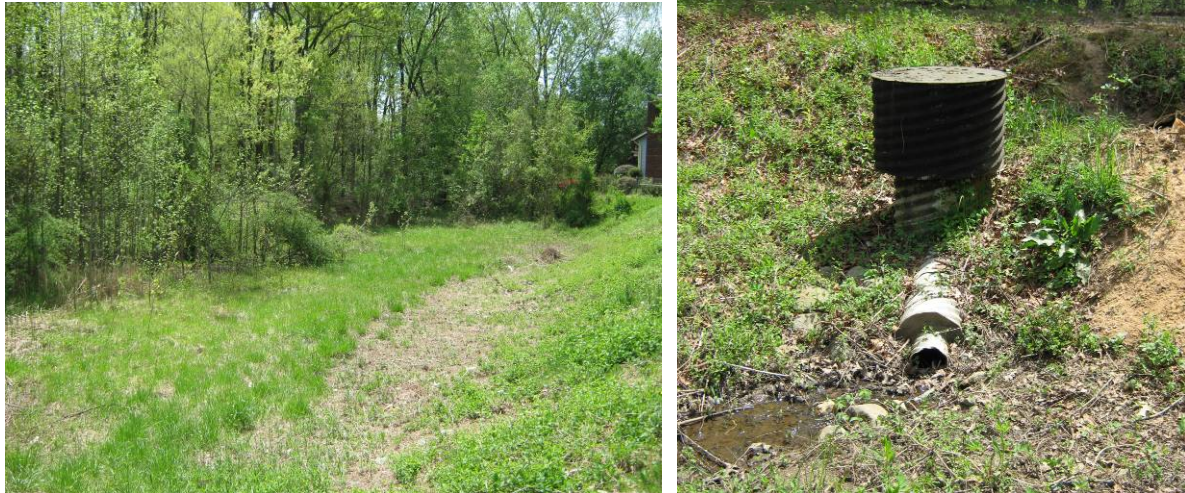
Figure 3-28: Detention Pond SWM-06 (Urbanwood Ct, Duck Creek)

Detention pond, SWM-06, is located at the end of the cul-de-sac on Urbanwood Court. It is bordered by two private residential properties on either side and by a forested stream buffer area and Duck Creek at the outfall both of which restrict physical expansion potential. The orifice and riser conditions were considered as in fair condition since some sediment was observed at the inlet and few cracks/minor weathering was noted for the riser. The overall condition of the existing detention pond is good with little to no debris and medium vegetation (thick grass and shrubs/trees). The outfall and downstream conditions were inaccessible due to fence conditions. The main recommendation for this facility is to monitor the condition of the inlet and riser and make sure maintenance of the pond continues to ensure proper function. This pond could be considered for planting of native vegetation that requires low maintenance while providing some water quality benefit. However, it may not be a priority since vegetation other than grass is well established and there is no room for physical expansion.

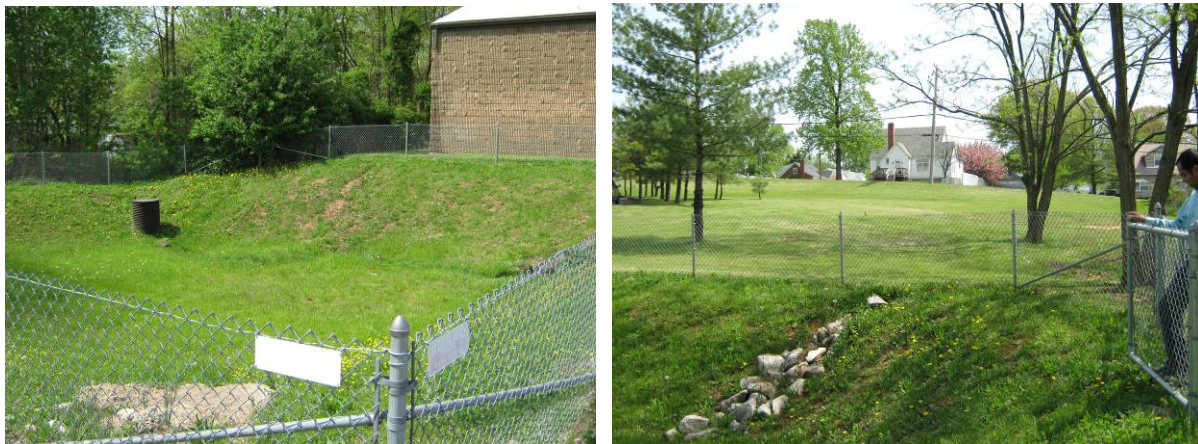
Figure 3-29: Detention Pond SWM-07 (Eyring Ave, Deep Creek)

Detention pond, SWM-07, is located off of Eyring Avenue adjacent to a commercial/industrial building and parking lot from which it receives stormwater runoff. It is bordered by forested and industrial areas. The orifice was rated as in good condition and the riser was considered fair since few cracks/minor weathering was observed. There is not a problem with debris. The status of existing vegetation was rated as low since it is completely open grassed area. Connection of the outlet of the pond was not clear but appeared to be connected to the storm drain system. This detention pond is the only facility out of the four surveyed considered to have conversion potential. The existing facility is enclosed by a fence; however, there is a large open grassed area in front of the pond adjacent to the parking lot and Eyring Avenue that is maintained (mowed) but does not appear to be utilized.

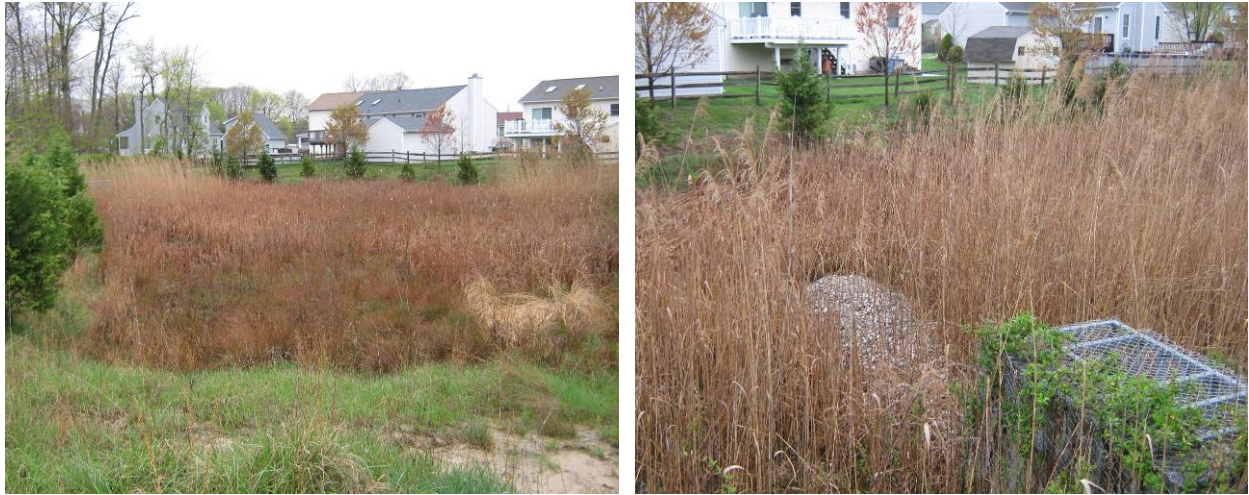
Figure 3-30: Detention Pond SWM-12 (Cape May Landing, Muddy Gut)

Detention pond, SWM-12, is located off of Turkey Point and Back River Neck Roads in the Cape May Landing residential development. It is bordered by the roads and private residences. The orifice and riser conditions were rated as in good condition with minor spalling at the weir. There is no debris issue nor ponding during dry weather. The vegetation status was medium since it was full of grass, shrubs, and small trees. The field team was unable to locate the outfall and thus, downstream conditions. There is no room for physical expansion of this facility due to adjacent land use conditions and therefore, no potential for conversion. Since the condition of the existing detention pond is good, proper maintenance and inspection is the main recommendation.

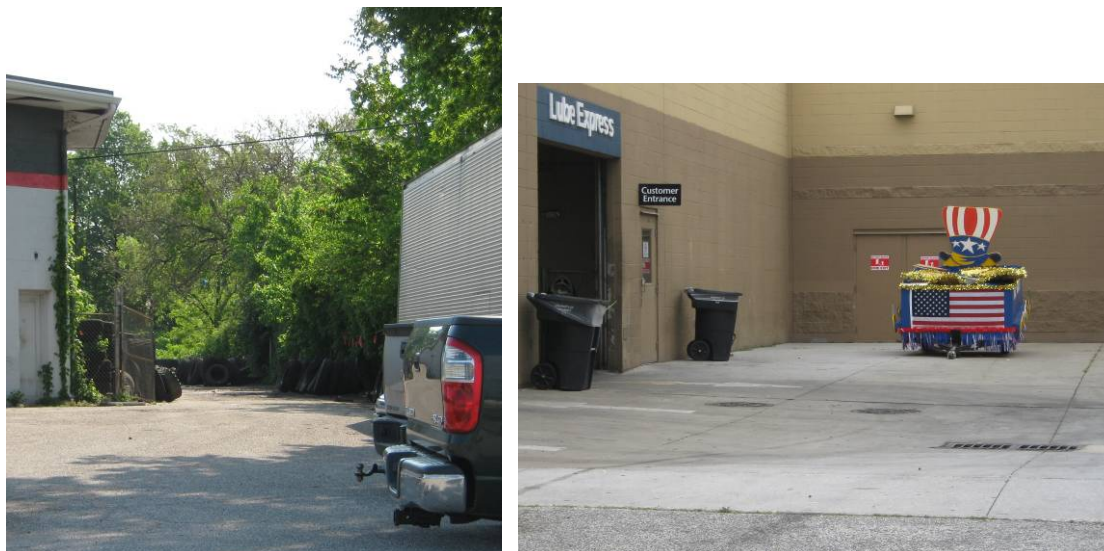
Figure 4-12: Examples of Potential Pollution Sources at Commercial (auto-related) Hotspots

There are several auto-related commercial establishments throughout the Tidal Back River watershed including auto repair shops, car dealerships, sales (e.g., car parts, accessories), tire service centers, gas stations, and car washes. The typical sources of stormwater pollution from this category of hotspots include vehicle, outdoor materials, physical plant, and waste management operations. Vehicle operations generally include repair, fueling, washing, and storing. Any of these activities can contribute potentially hazardous pollution to the storm drain system if proper housekeeping is not performed or if impervious surfaces lack diversions or treatment for stormwater runoff. In some cases, materials such as tires are stored outdoors. If materials are uncovered and stored on an impervious surface, there is potential for any vehicle-related pollutants attached to the materials to be washed off during a storm event into the stream or storm drain system (see Figure 4-12, left). It is also common for impervious surfaces (parking lots) at these type of hotspots to be stained as a result of vehicle operations or outdoor material storage which can also result in pollutants being transported by stormwater runoff (see Figure 4-12, right). The main recommended action for these types of operations is to include in future education efforts explaining proper storage of outdoor materials (covered, store on pallets not directly on pavement), ensure adequate buffer or diversion methods for stream/storm drain system, and incorporate treatment of stormwater runoff where possible.

All commercial operations generate waste and auto-related enterprises have potential to generate hazardous pollutants that can enter the stream or storm drain system. For example, at a sales establishment for car parts and accessories assessed, trash from the store was observed around the site and along the fence separating the nearby stream from the property (see Figure 4-13). This included an assortment of trash such as paper and plastic bottles with potentially hazardous liquid remains (antifreeze, oil, etc.) Again, future education could help address waste management related efforts. This may include proper waste management operations such as closing dumpster lids, creating runoff diversion between dumpsters and stream/storm drains, proper disposal of hazardous materials, and providing more trash

receptacles in the parking area for clients. It may also involve educating clients about the hotspot and harmful effects of trash getting into the stream (community clean-up).

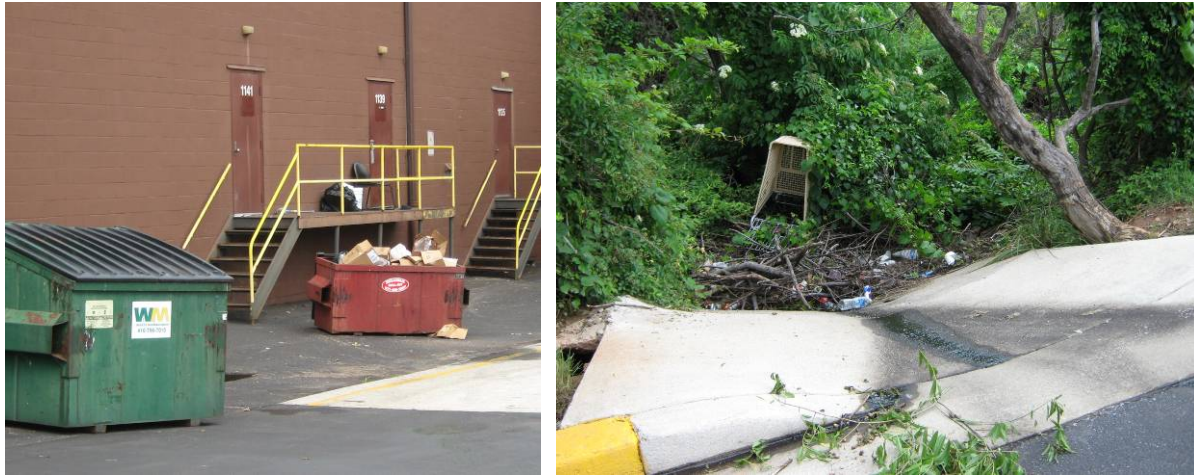
Figure 4-14: Examples of Overflowing Dumpsters and Curb Cuts Leading to Stream

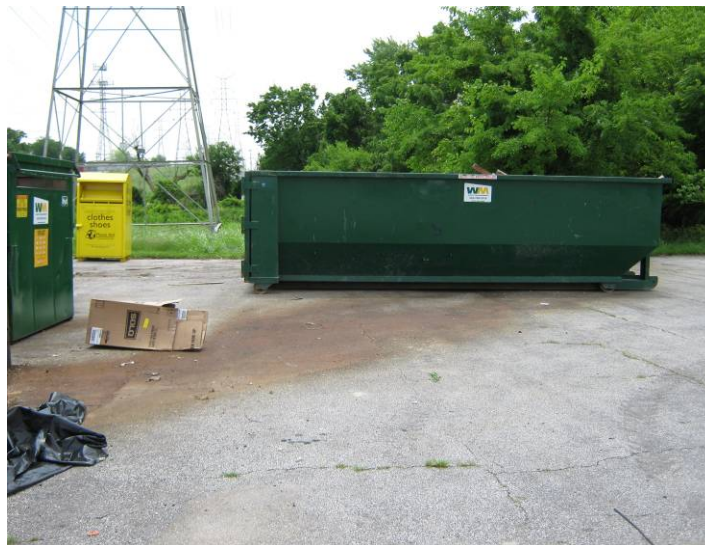
Figure 4-15: Potential Pollution Source from Stained Parking Lot/Leaking Dumpster

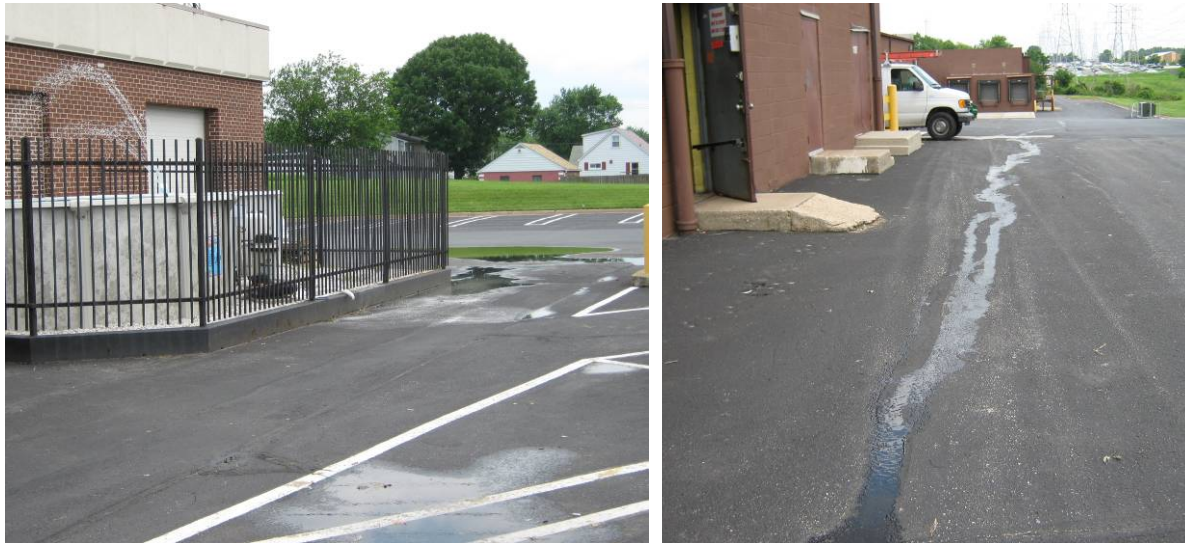
Figure 4-16: Runoff from Outdoor Material Areas at Commercial Hotspots

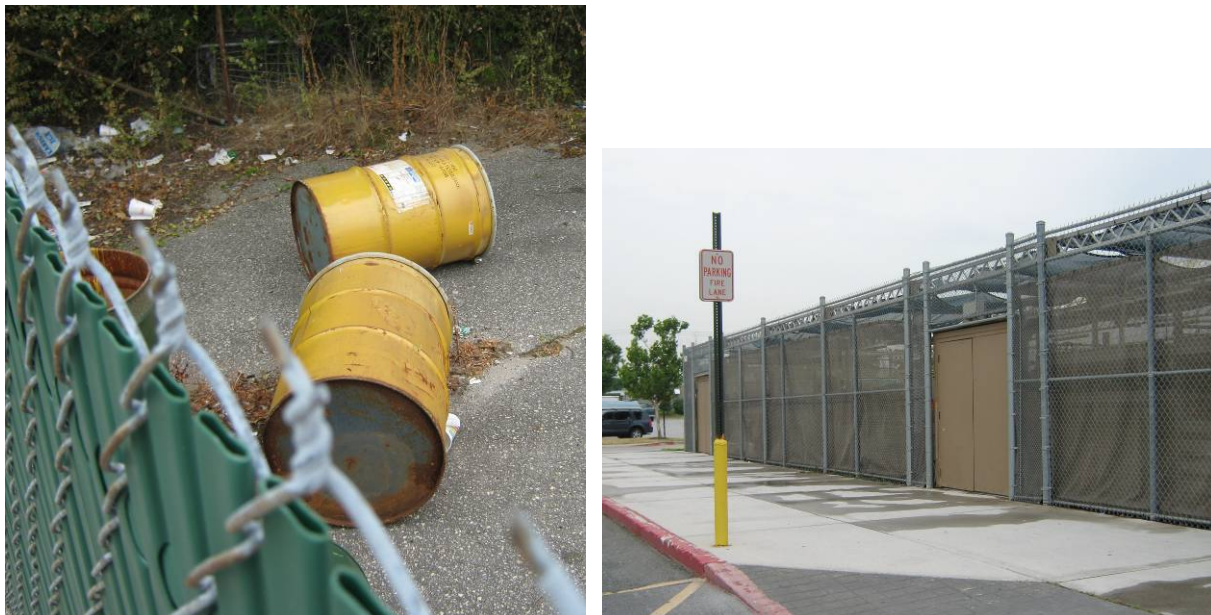
Figure 4-17: Potential Pollution Sources at Commercial Hotspots

Commercial areas sometimes have outdoor shopping areas where materials are stored outside. Similar to the discussion above, if materials are uncovered and on impervious surfaces, runoff from these areas can go directly into the storm drain system along with certain pollutants depending on the type of materials. For example, Figure 4-16 shows an outdoor pool display leaking/spraying water onto an adjacent impervious surfaces. This discharge may contain chemicals such as chlorine which can end up in the storm drains or streams. The left photo in Figure 4-17 shows a commercial shopping area where improperly labeled drums were stored

outdoors on pavement and sideways. This has potential for potentially hazardous pollutants to leak into the adjacent stream. The photo on the right in Figure 4-17 shows an outdoor garden center. While the outdoor garden center was covered, runoff from non-target irrigation practices was observed on the adjacent sidewalk indicating lack of diversion methods for storm drain inlets.

Diversions to prevent stormwater runoff and trash from discharging directly into the stream or storm drains are one recommended follow-up action for commercial hotspots. Another is to educate store owners about proper waste management and outdoor material storage

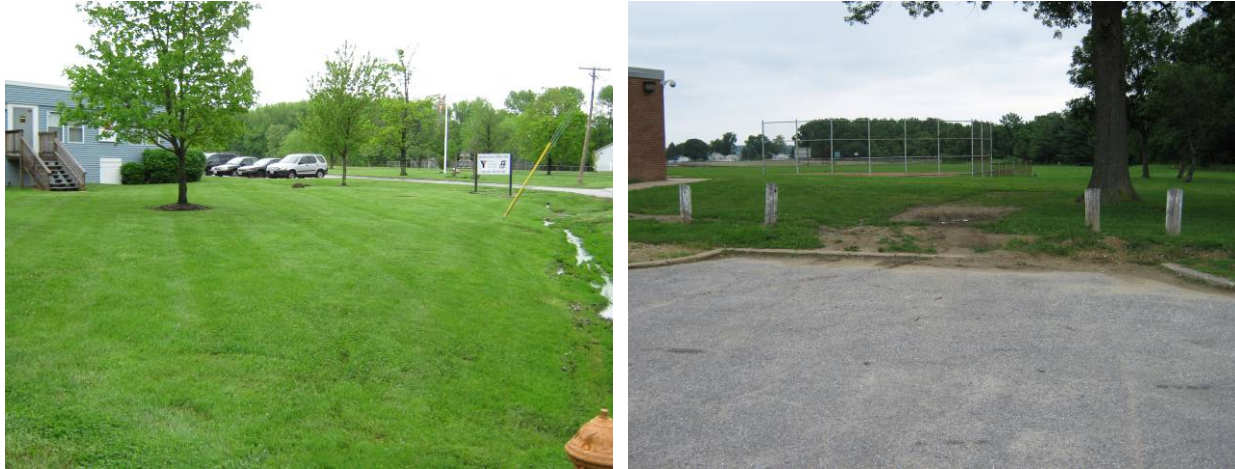
Figure 4-19: Stormwater Retrofit Opportunities at ISI_E_300 (left) and ISI_E_1001 (right)

As shown in the table above, the actions that were recommended the most were storm drain marking (19 sites) and stormwater retrofits (15 sites). Downspout disconnection was recommended for 1 public and 5 private institution sites where sufficient pervious area was available to redirect rooftop runoff. All of these actions present an opportunity to educate the community about the connection between the storm drain system and the Back River and how their actions can impact or improve water quality. Stormwater retrofits were recommended at 7 public institutions (6 schools, 1 police station) and 8 private facilities (4 faith-based, 2 community centers, 2 care centers). Stormwater retrofit opportunities included treating runoff from parking lots, inlet retrofits, and conversion of existing pervious area to wetlands. Sites where sufficient pervious area was available to treat a portion of the runoff from an impervious parking lot could implement infiltration/filtration practices such as trenches, basins, or bio-retention that incorporate vegetation and filter media through which storm water infiltrates for pollutant

removal prior to groundwater recharge or entering the stream system. Two examples of stormwater retrofit recommendations for parking lots are shown in Figure 4-19. The photo on the left is the day care center at the Back River Community Center in Muddy Gut where a large pervious area is available adjacent to the impervious parking area. This is a good opportunity to address runoff from the parking and ponding that occurs in the adjacent ditch and also treat runoff before it enters the inlets in the grassed area. The photo on the right is a parking area at Sparrows Point Jr. and Sr. High School where runoff from the parking lot appears to be causing sediment buildup, erosion, and ponding.

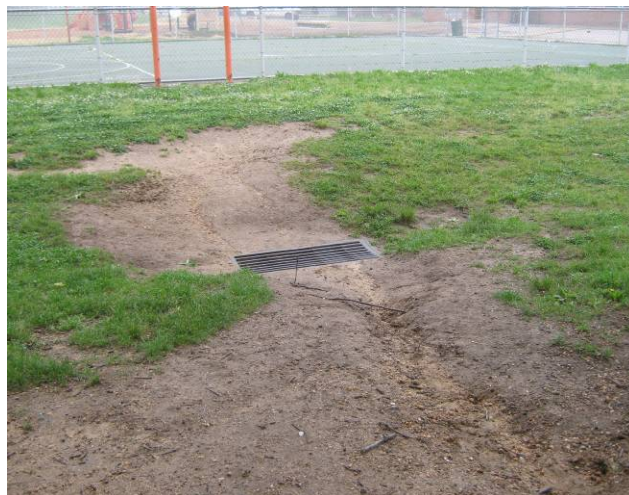
Figure 4-20: Stormwater Retrofit Opportunities at ISI_E_700

Inlet retrofits were recommended for sites where considerable ponding of water and/or bare soil was observed around storm drain inlets on the property. Planting native vegetation around these inlets would help stabilize soil, reduce sediment and flow input into the storm drain system, and provide some infiltration/treatment prior to runoff entering the ground and inlet. Figure 4-20 shows an example of a site recommended for this type of stormwater retrofit at Eastwood Center in Bread and Cheese.

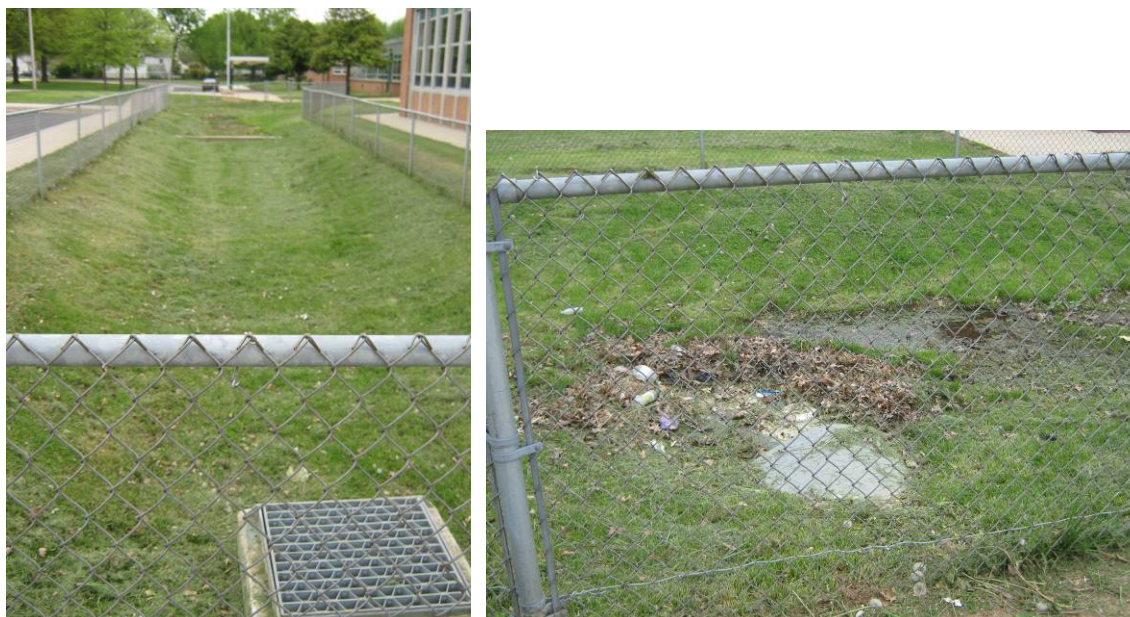
Figure 4-21: Stormwater Retrofit Opportunity for an Existing Detention Pond at ISI_E_101

Two schools have potential for wetland creation as a stormwater retrofit project. At Deep Creek Elementary School, a detention pond was observed next to a parking area that was grassed with some standing water and organic matter (see Figure 4-21). This site was noted as a good opportunity to retrofit the existing detention pond to a wetland area which would require less maintenance while providing more water quality benefits such as filtration of stormwater pollutants and wildlife habitat. Deep Creek Middle School appeared to have an unused field in the rear of the property suitable for a new wetland creation adjacent to a wooded stream buffer. This will be discussed further in the PAA section. Both of these sites represent an education opportunity for students and parents about stormwater retrofits and water quality benefits for Back River.

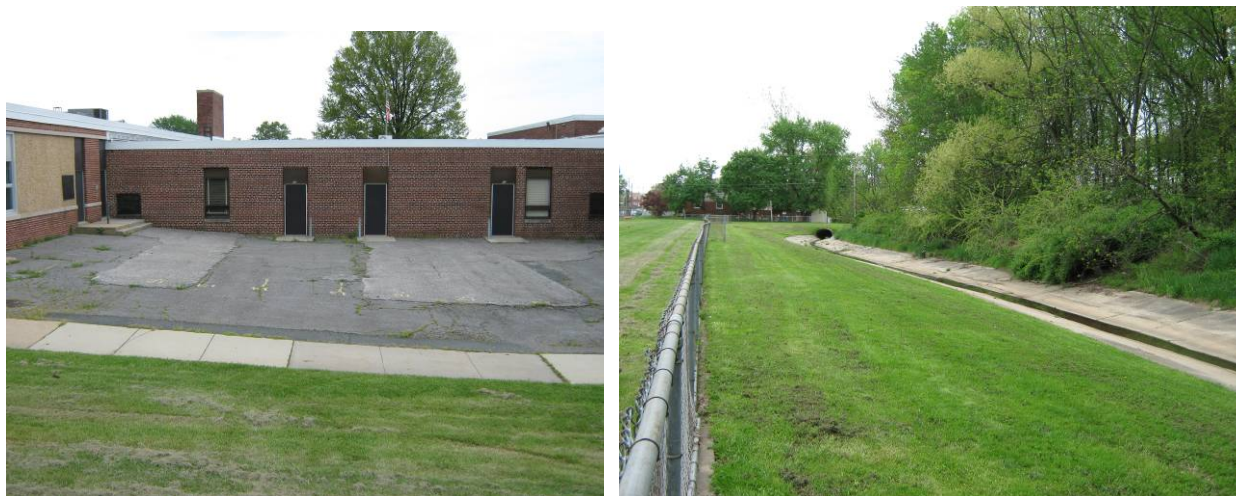
Figure 4-22: Potential Impervious Cover Removal at ISI_E_100

Impervious cover removal was a recommended action for 8 out of the 27 institutions investigated. It was a recommended action for sites where a considerable impervious area appeared to be abandoned or underutilized such as parking lots, walking paths, and athletic courts. It also included areas where impervious cover was not absolutely necessary and appeared to be damaged (patched, breaking up) such as areas on the side or behind buildings, areas between building and parking lot, or areas between walkways/sidewalks. Of the 8 sites recommended for impervious cover removal, 6 are public schools. One of these was Mars Elementary School in Deep Creek shown in Figure 4-22. The photo on the left in Figure 4-22, shows an impervious area in the back of the school building that is breaking up and that has

patchwork and grass growing through it. This indicates that the area is not used frequently or maintained and could potentially be removed to provide greater potential for runoff infiltration. Adjacent to the athletic field on the opposite side of the fence is a concrete-lined channel that could also be a potential opportunity for impervious cover removal and restoring the stream to a more natural system including buffer improvement.

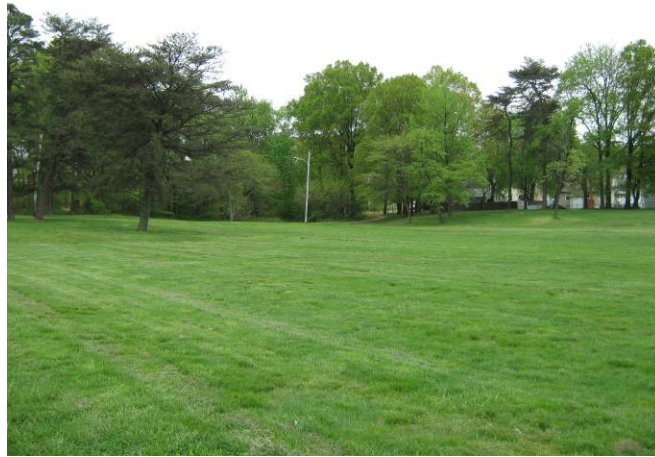
Figure 4-24: Photo of PAA_E_100

Martindale Park is located at the end of Homberg Avenue in Deep Creek and is maintained by Baltimore County Parks and Recreation. The park is approximately 3.2 acres and consists mostly of turf cover (85%) with some existing trees. There is one maintained baseball field and another baseball field that appears to be no longer utilized. This site was recommended for reforestation with minimal site preparation to extend the existing forested buffer area between the park and Deep Creek based on initial field observations. This site receives full sun exposure and is easily accessible by foot, vehicle, and heavy equipment. Reforestation of a portion of the site would require verification that it would not interfere with the current use of the site and tree planting could be a potential community project.

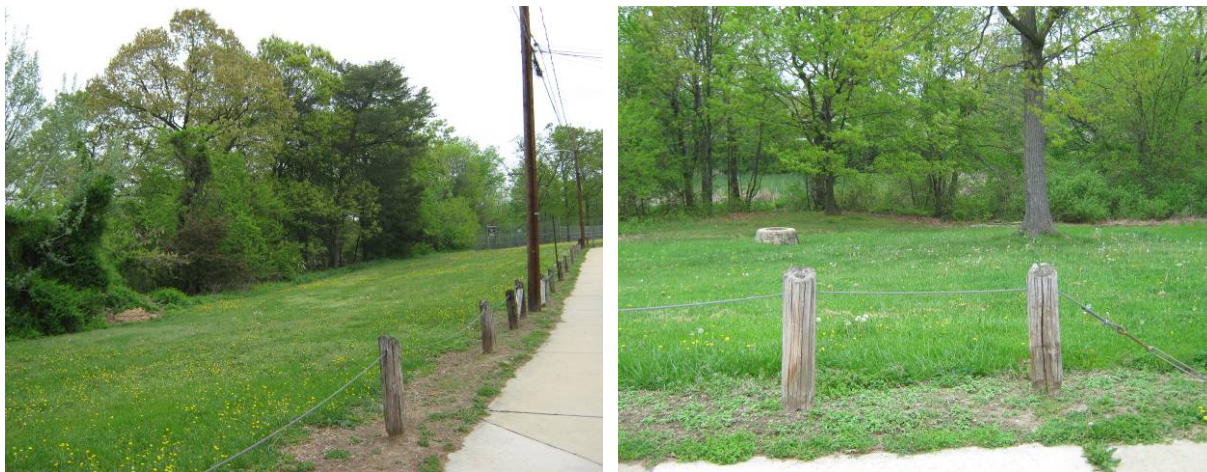
Figure 4-25: Photos of PAA_E_101

Fox Ridge Park is located between Deep Creek and the alley behind Foxwood Lane. It is also maintained by Baltimore County Parks and Recreation and easily accessible by foot, vehicle, or heavy equipment. It is mostly covered by turf (75%) with some trees and a paved athletic court. This site was recommended for reforestation with minimal site preparation based on initial field observations. Since the site is only 1.5 acres, reforestation was recommended mostly to improve the forested buffer area along Deep Creek. The current use of the park will need to be evaluated during a follow-up visit if the site is selected for potential restoration to balance buffer improvement with pervious area available for recreation. This could also be a community tree planting project.
