Tidal Back River Small Watershed Action Plan

Volume II

Tidal Back River Watershed Characterization Report

October 2009

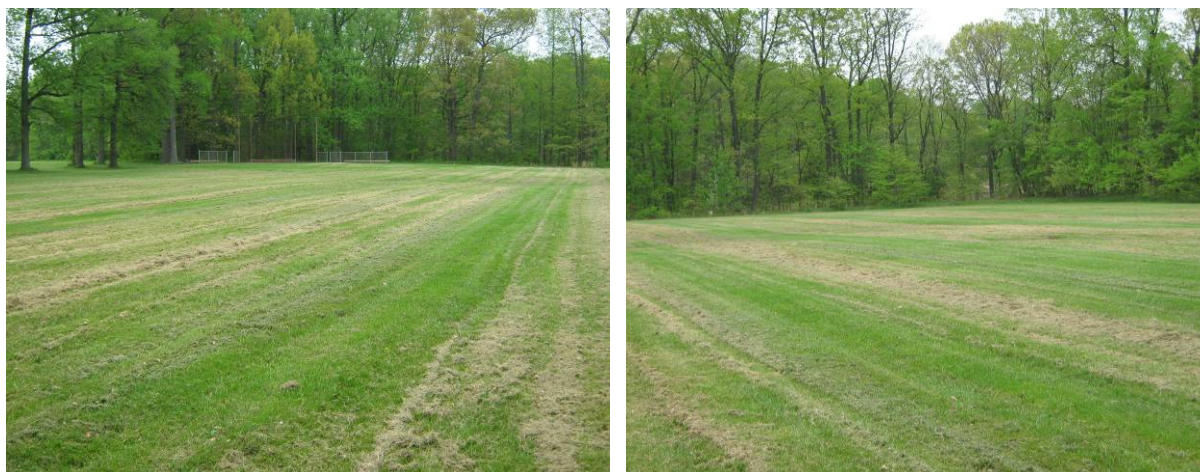
Figure 4-26: Photos of PAA_E_200

A PAA was conducted for an isolated pervious area between Deep Creek Middle School main building and Back River. It was considered to be a good candidate for natural regeneration and for reforestation within minimal site preparation. The site is approximately 2.6 acres with full sun exposure and 100 percent turf cover. This site was recommended because the open pervious area appeared to be an unused baseball field and was isolated from the rest of the school property by existing trees. Because the open pervious area is located so close to the Back River, it was also noted as having potential for wetland creation. This would connect the surrounding forested buffer area while providing increased wildlife habitat and water quality benefits as well as an education opportunity for the school. Reforestation and wetland planting using native plants would require less maintenance than current mowing operations. A follow-up site inspection would involve verifying that the field is no longer used by the school for recreational purposes and a closer look at invasive species noted at the edge of the adjacent forested buffer area.

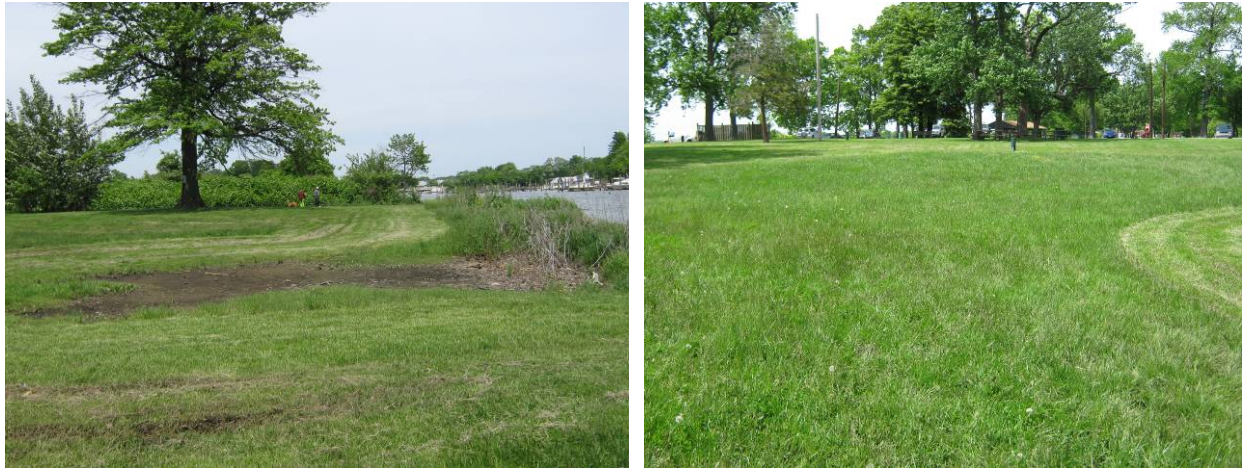
Figure 4-28: Potential Reforestation Areas at PAA_E_400

Cox's Point Park, located in Duck Creek at the end of Riverside Drive, is maintained by Baltimore County Parks and Recreation and is the largest public pervious site (~18.5 acres) assessed as part of this study. The pervious portion of the park was estimated as mostly turf cover (50%) and trees (35%) with some wetland plants, shrubs, and bare soil (15%). This site was recommended for reforestation with minimal site preparation mostly for stream buffer improvement purposes which needs to be balanced with park uses and public access to the river. Some trash and dumping was noted as an impact that may also influence pervious area restoration. Several areas were observed where there was bare soil, ponding, and where grass was not mowed as frequently as other turf areas. This indicates that these areas are not used for recreational purposes and where reforestation or planting could be enhanced. The field team also noted a potential storm water retrofit opportunity for one of the parking lot areas where practice such as bioretention would address bare soil and runoff prior to entering the Back River.

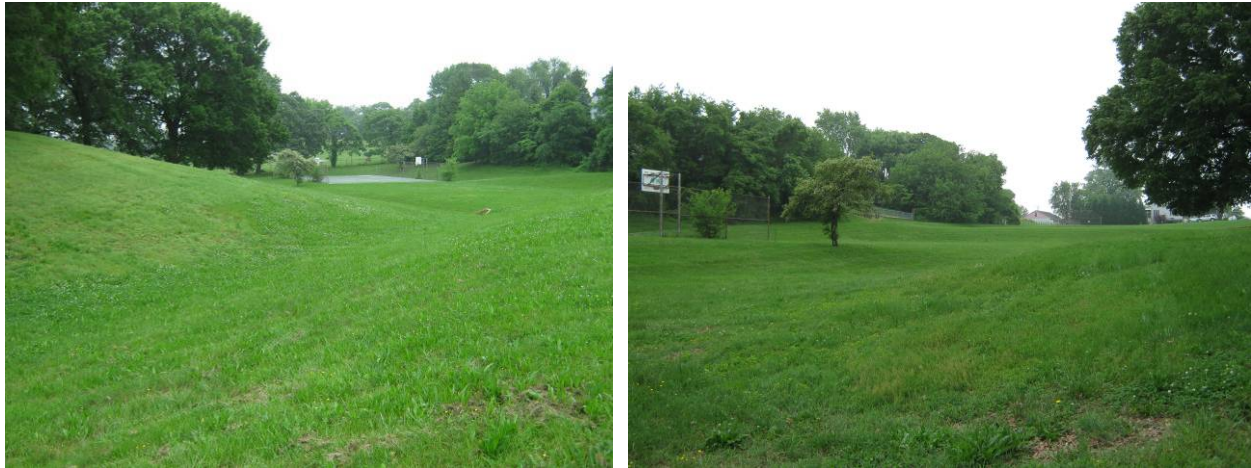
Figure 4-30: Potential Reforestation Areas at PAA_E_700

Harbor View Park is located off of Woodrow Avenue in Bread and Cheese and is bordered by residential areas and Oak Lawn Cemetery. It is maintained by Baltimore County Parks and Recreation and is approximately 4.2 acres. The site is mostly turf cover (70%) with some trees (30%) and receives full sun exposure. It is easily accessible by foot, vehicle, or heavy equipment. The shape of the land at the park creates a natural grassed channel that leads to an inlet to the storm drain system. This site was recommended for reforestation with minimal site preparation since plantings would not interfere with use of the baseball field or basketball court areas and the limited flat pervious areas. The field team also noted an opportunity for stormwater retrofit to treat runoff from the small impervious parking area. This may involve filtering/filtration practices such as a bioretention area to treat runoff and address bare soil before entering the storm drain inlets on site.

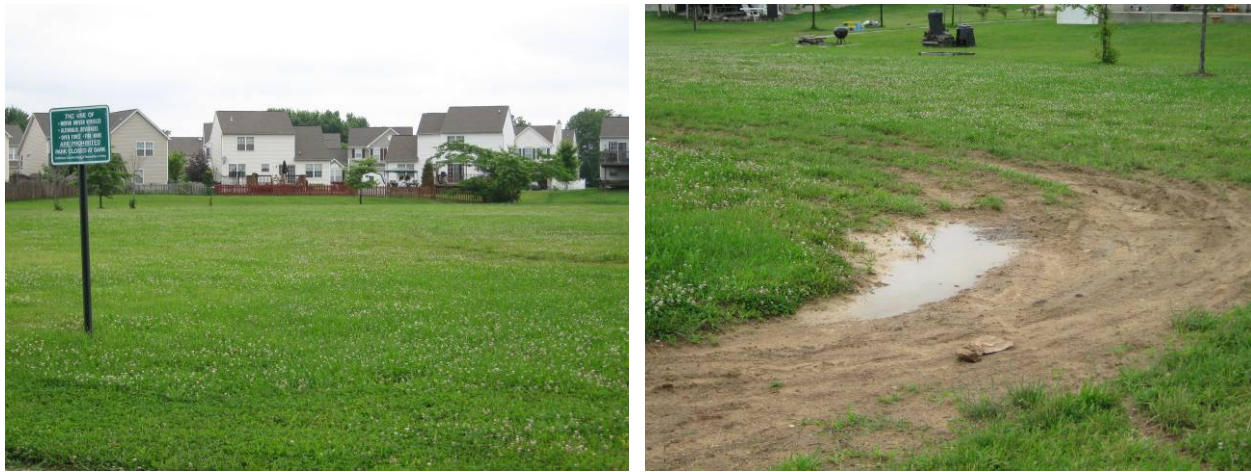
Figure 4-32: Photos of PAA_E_800

Beachwood Estates Park is located off of Greencove Circle in Back River-A and is easily accessible by foot, vehicle, or heavy equipment. It is maintained by Baltimore County Parks and Recreation and is approximately 2.6 acres. The site consists mostly of turf cover (70%) with some trees (15%) and a considerable amount of bare soil (15%) and receives full sun exposure. The site was recommended for reforestation with minimal site preparation. Erosion and backyards of private residences were noted as potential reforestation constraints. Some trees have been planted between private residences and the park; this buffer could be enhanced by planting additional trees while also stabilizing areas that appear to be prone to erosion.
